Risk-based Management of Energy Infrastructure
at TOKYO ELECTRON House of Creativity 3F,
Lecture Theater, Katahira Campus, Tohoku University

Evaluation of degradation of high temperature materials including coatings in a reducing environment

Xie Yang, Jiyuan Cui, Hiroki Saito, Kazuhiro Ogawa

November 9, 2023

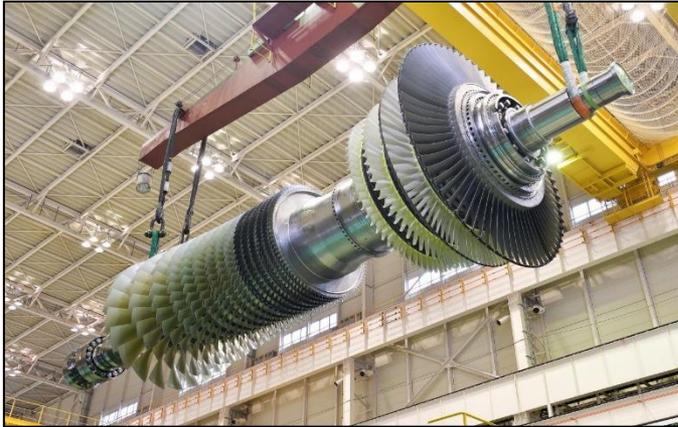
A diagram of a gas turbine engine
<https://car.motor-fan.jp/tech/10014243>

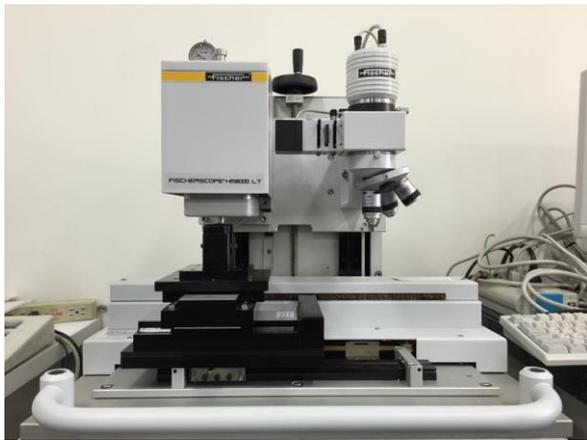
The microhardness testing system
FISCHERSCOPE HM 2000

Micro-Vickers
indentation test
conditions:
Load: 100 mN/15 s
